## Ecoglo International Ltd

## Ecoglo HYU Hybrid Photoluminescent Exit Signs: Compliance with NZBC F8/AS1

Ecoglo HYU hybrid exit signs are photoluminescent exit signs that are charged with an integrated light source. The light source ensures the signs are sufficiently charged at all times to meet the requirements of the New Zealand Building Code (NZBC) Clause F8/AS1.

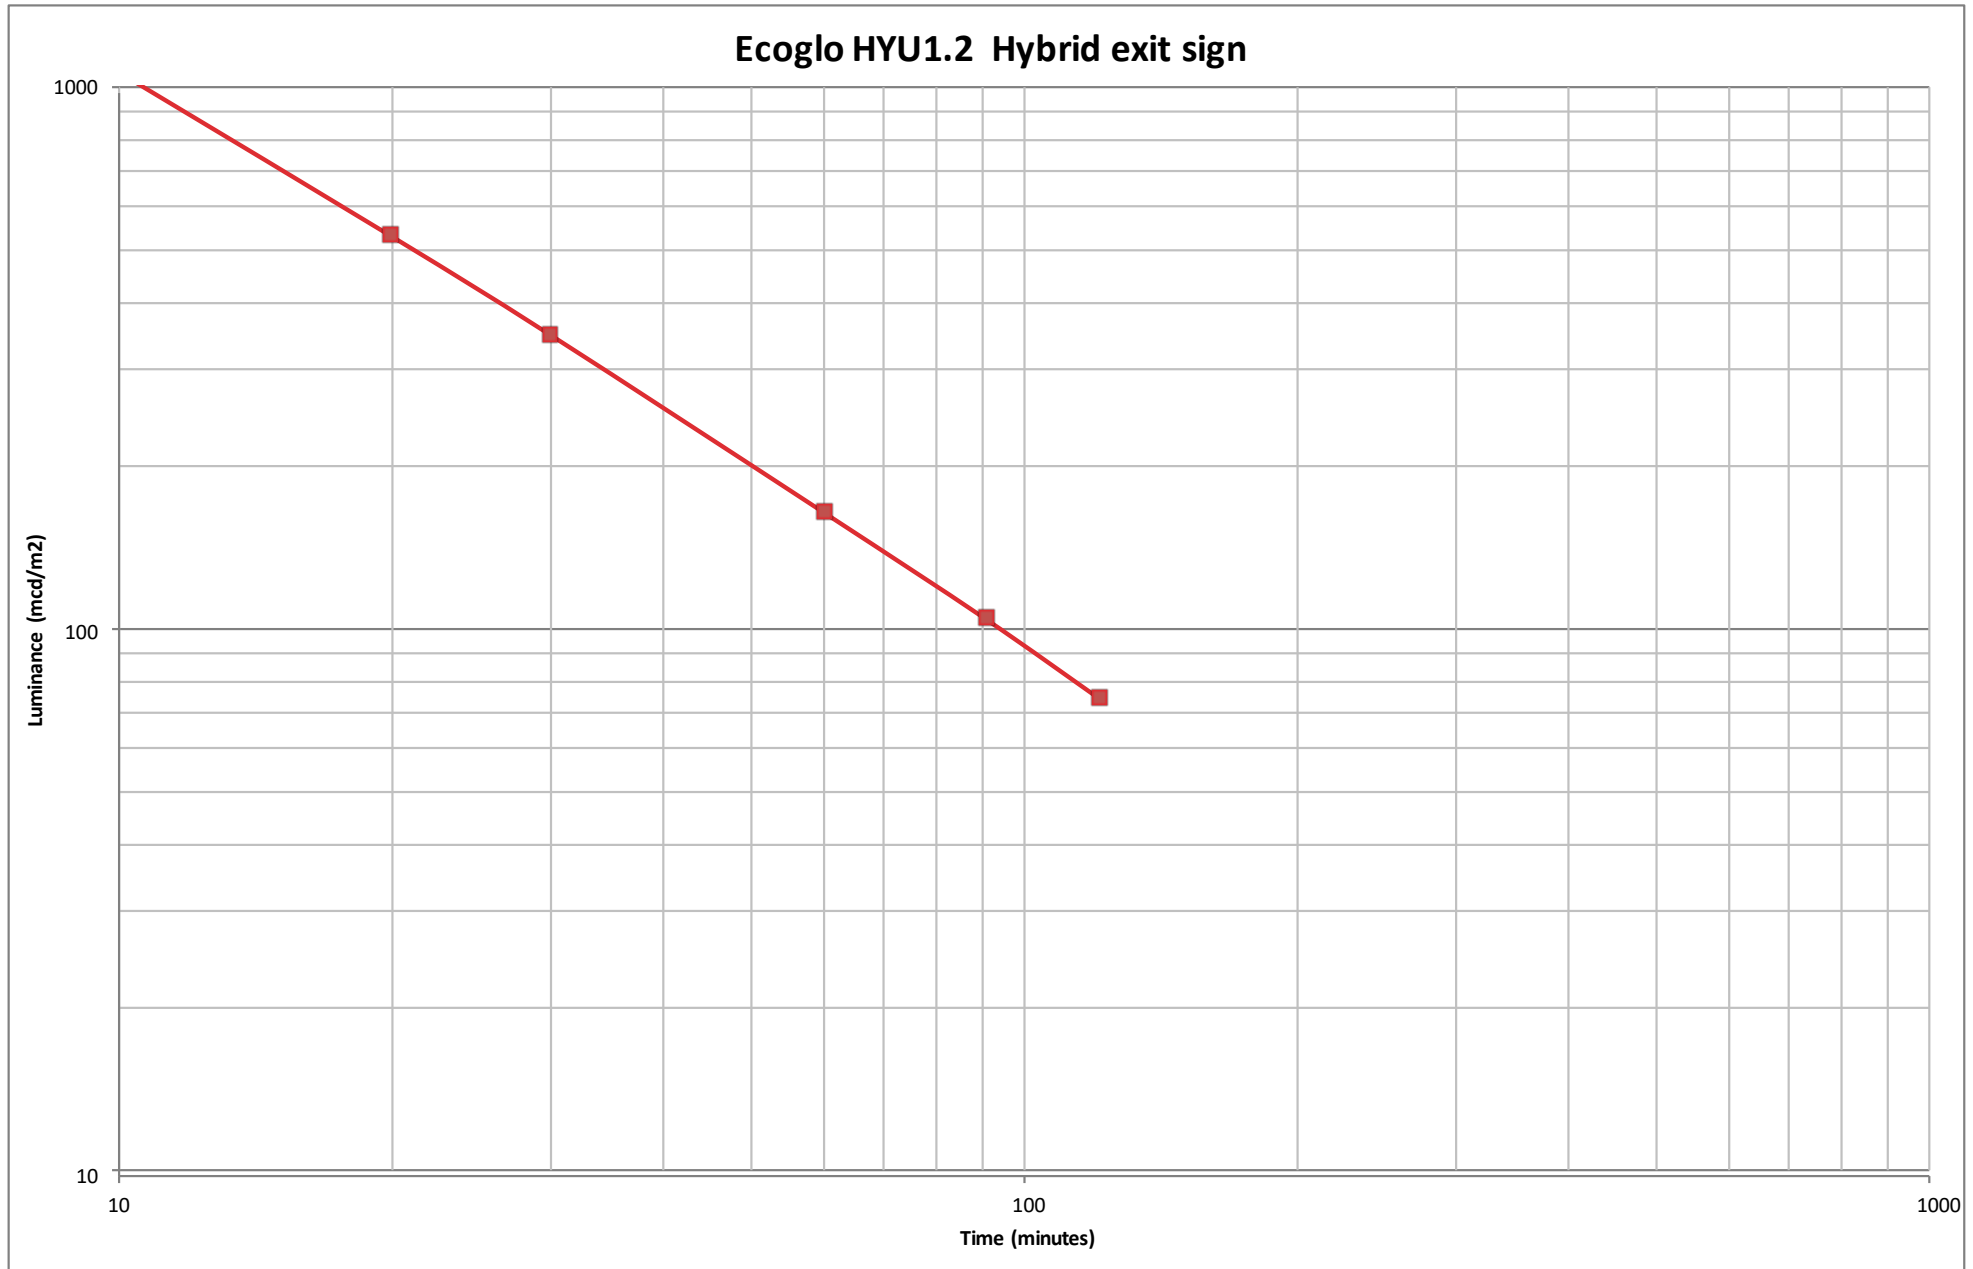
1-Sep-20 h221

Test ID	Date	Test Sample	Charging Lamp Type	Illuminance on Sample	Charging Time
h221	1 Sep 2020	HYU1-2	Integral LEDs	N/A	60 minutes

HYU1.2

Batch 4619 07/20, Sign 14

Minutes	10	20	30	60	90	120
mcd/m2	1064	530	348	164	105	75

The data below and chart (Appendix A) is extracted from Ecoglo records for the following in house test:

The test results revealed that the luminance at 30 minutes is 348mcd/m<sup>2</sup>, clearly well above the 30mcd/m<sup>2</sup> required. At this level, even if the integrated light source were to lose as much as 50% of its initial brightness during its lifetime, there would still be sufficient luminance.

The test results revealed that the luminance at 90 minutes is 105mcd/m<sup>2</sup>, clearly well above the 30mcd/m<sup>2</sup> required. At this level, even if the integrated light source were to lose as much as 50% of its initial brightness during its lifetime, there would still be sufficient luminance.
