Technical Justification
Alternative Solution
for

Ecoglo S20 Photoluminescent Exit Signs

To meet the Exit Signage Requirements of NZBC Clause F8 'Signs'

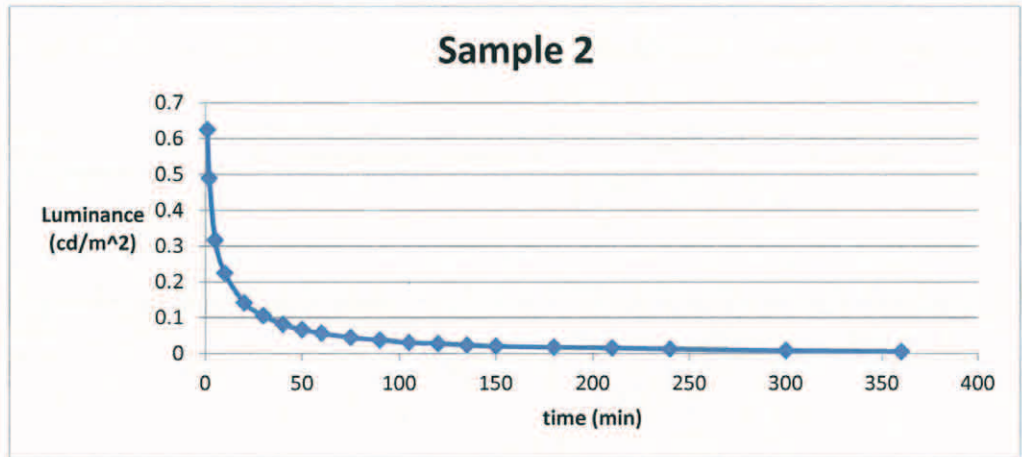
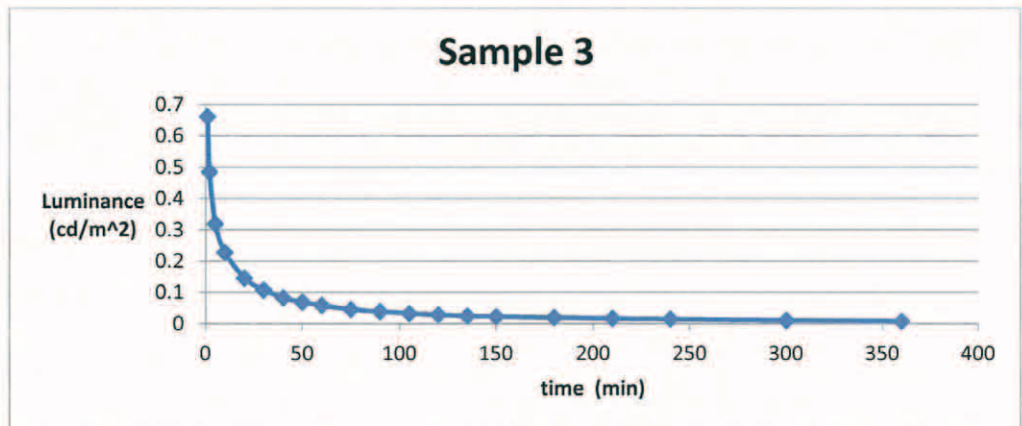
Graphs of decay- Samples exposed to 36W 8400 fluorescent lamp source

Figure 1. The luminance decay over time of the sample exposed to 8400 fluorescent light source.

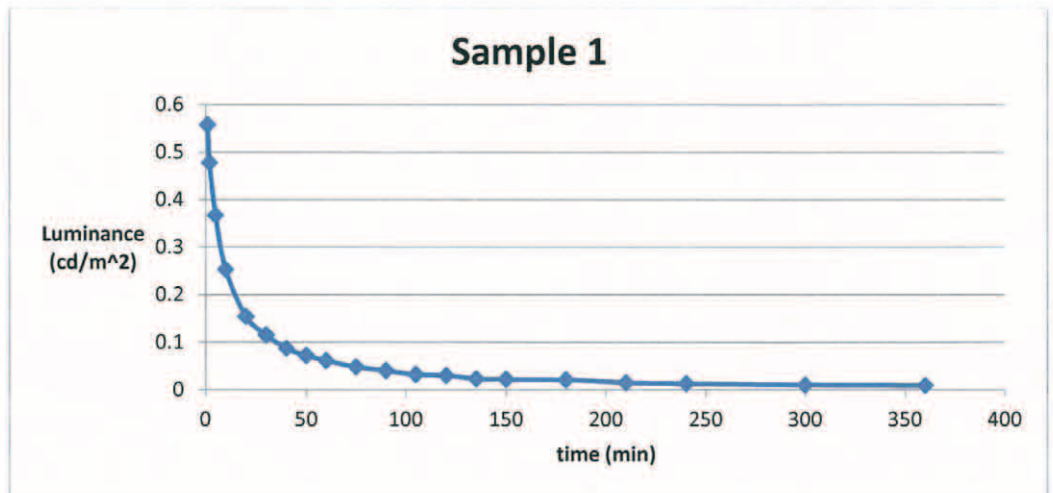
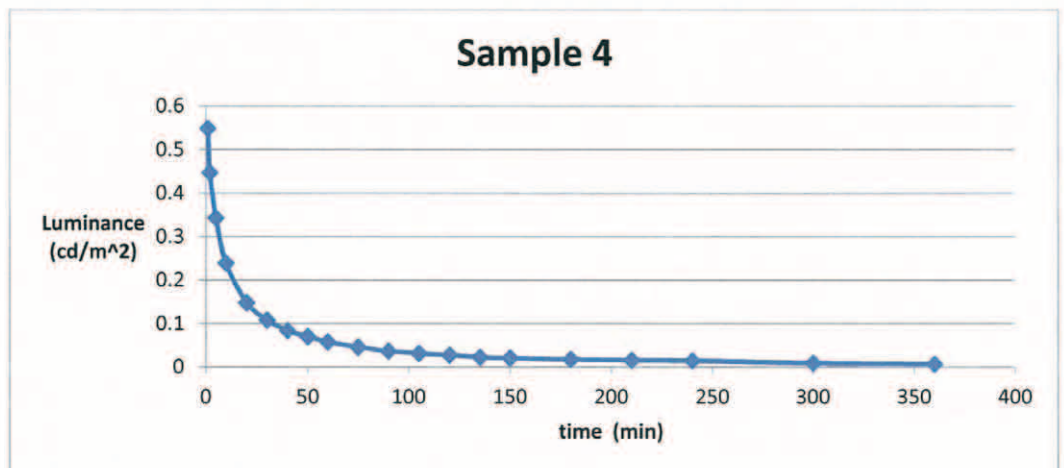
Graphs of decay – Samples exposed to 36W 8400 and 8500 fluorescent lamp source

Figure 2. The luminance decay over time of the sample exposed to 8400 and 8500 fluorescent light source, giving a resulting CCT of 4500 ± 50 K.

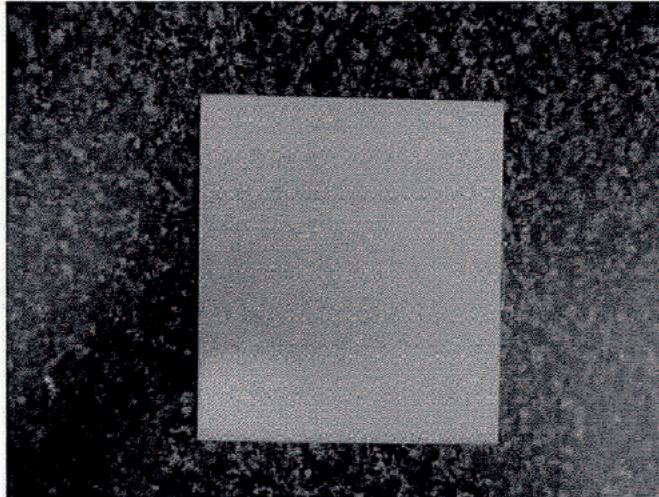
PHOTOS OF THE ECOGLO S20 SERIES MATERIAL SUPPLIED FOR TESTING

Photoluminescent Surface

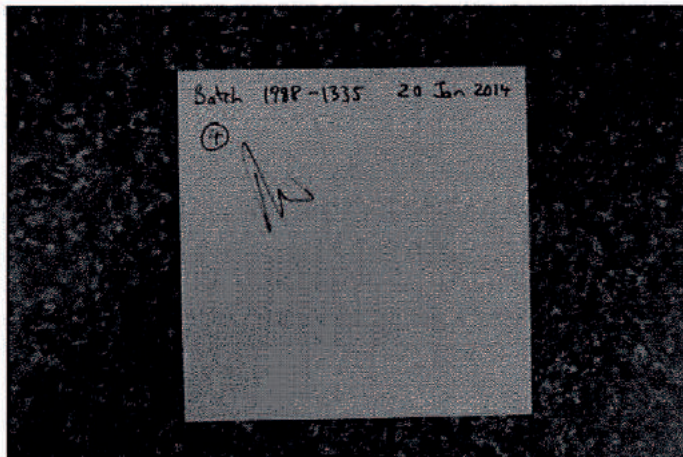
Rear Surface with ID markings as supplied by the Client

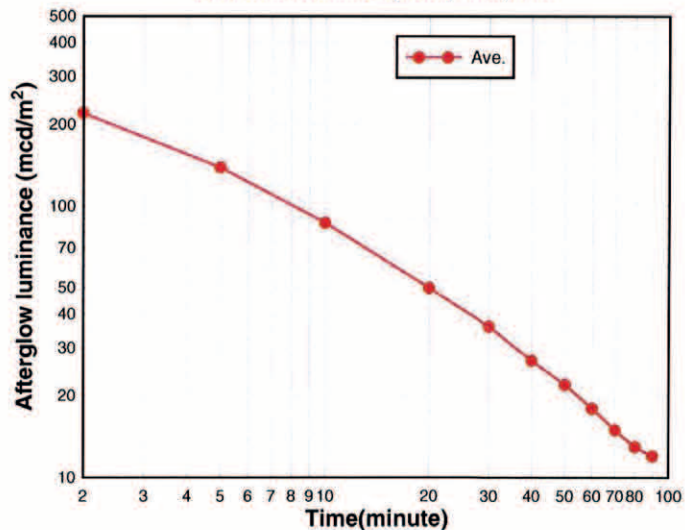
Fig. Afterglow Luminance of Ecoglo S20 sign material

Excitation:WFL FL15W(4200K) 100lx, 5min.
